# Manhole Inspection Summary

## Manhole # S35UU1027MH

Insp Date: **10/29/08 1:58 PM**

**Location** Address: **401 CHADFORD RD**

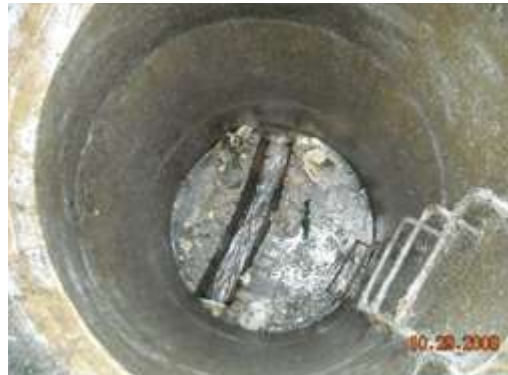
Top View

**Steps** Count: **7** Missing: **0** ☒ **Corroded**

**Surcharge** ☒ **Evidence Of Surcharge** Depth: **3** (ft.) ☐ Active Surcharge Present

Corroded steps. Evidence of surcharge - Bench debris.

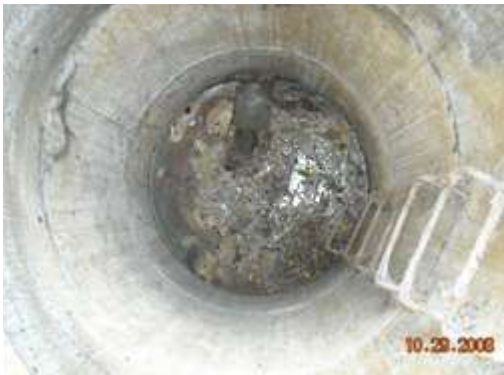
Top View

Unable to complete inspection - needs cleaning.

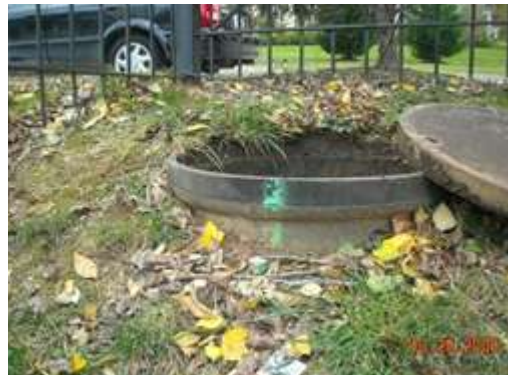
Defect

Above grade.

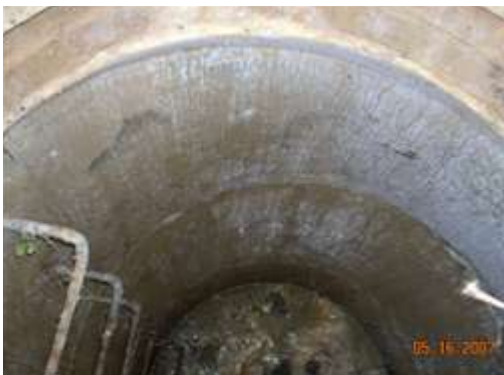
Defect

**Frame** Offset: **0** (in.) Condition: ☐ Sound ☐ Cracked ☒ **Leaks**

Infiltration: ☐ None ☒ **Joint** ☐ Cracks ☐ Mortar ☐ Roots ☐ Wall

Frame leak. Adjustment infiltration

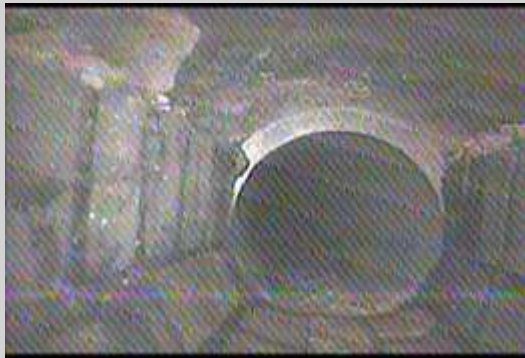
### 8 in. Circular Gravity Sewer Pipe Out @ 12 O'Clock

Rod and Bar (Angled)

Invert Depth: **9.92** (ft.) Flow Characteristics: **Slow**

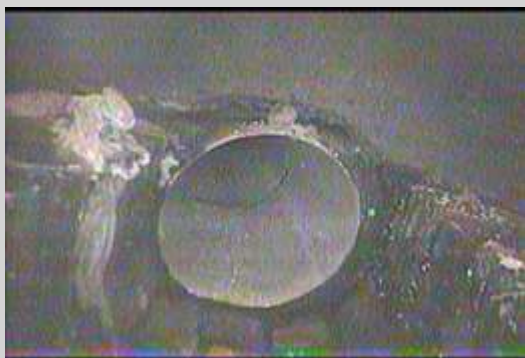
### 8 in. Circular Gravity Sewer Pipe In @ 7 O'Clock

Rod and Bar (Angled)

Infiltration: **Evidence** Pipe Seal Cond: **Unknown**
